# STUDY ON EVALUATION METHOD FOR DETERIORATED BRIDGE SLABS BY SELF-PROPELLED IMPACT VIBRATION EQUIPMENT

Dissertation

Graduate School of  
Natural Science & Technology  
Kanazawa University

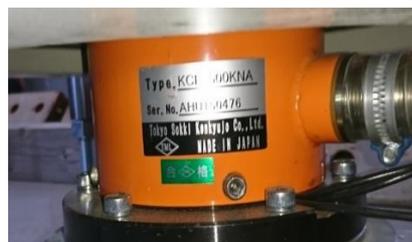
**Figure 2.4: Load cell (Tokyo Instrument KCE-500kNA)**

The impact load at the loading point was measured using the load cell inside the loading machine described above. Figure 2.4 shows the load cell. The capacity is  $\pm 500$  kN, and it is installed at a position sandwiched between the shock absorber and the loading board.

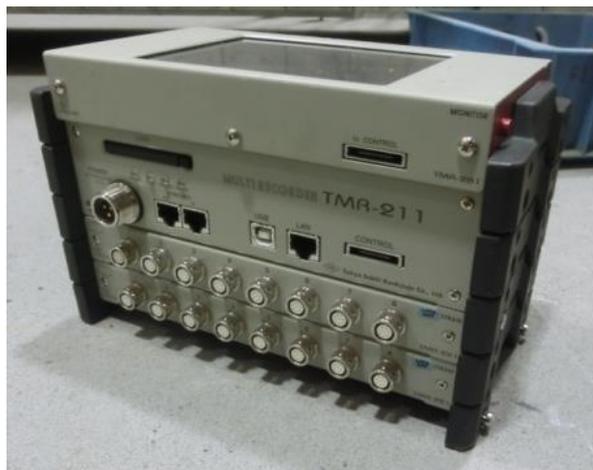
**Figure 2.7 Measurement logger**

The instrument shown in Figure 2.7 was used as a measurement logger. This logger, the load cell and each accelerometer are connected by wires.

A displacement gauge with a range of  $\pm 10$  mm was used. The installation method, as shown in Figure 2.8, the bars were placed between bridge and fixed by using vise so as not to move in the vertical direction. As a result, relative displacement of the floor slab was measured. The measurement logger of this, like the other equipment mentioned above, the logger of Figure 2.7 was used.

value was obtained as measured displacement. Also, a logger different from the one in Figure 2.7 is used for the measurement logger of this displacement gauge, and it is not synchronized with the other measuring instruments mentioned above at the time of measurement.

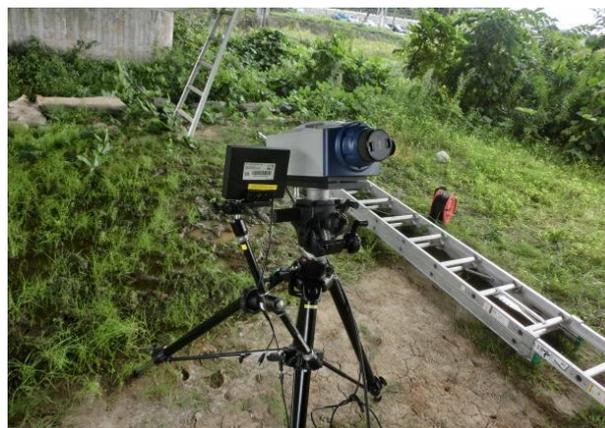
**Figure 2.9: Laser displacement meter installation**

The laser displacement meter was installed on the riverbank under the floor as shown in Figure 2.9. Regarding the method of measuring the displacement, the laser was emitted and reflected on the deck, the speed was measured from the time it sensed by the laser displacement meter, processing such as integration was performed, and the

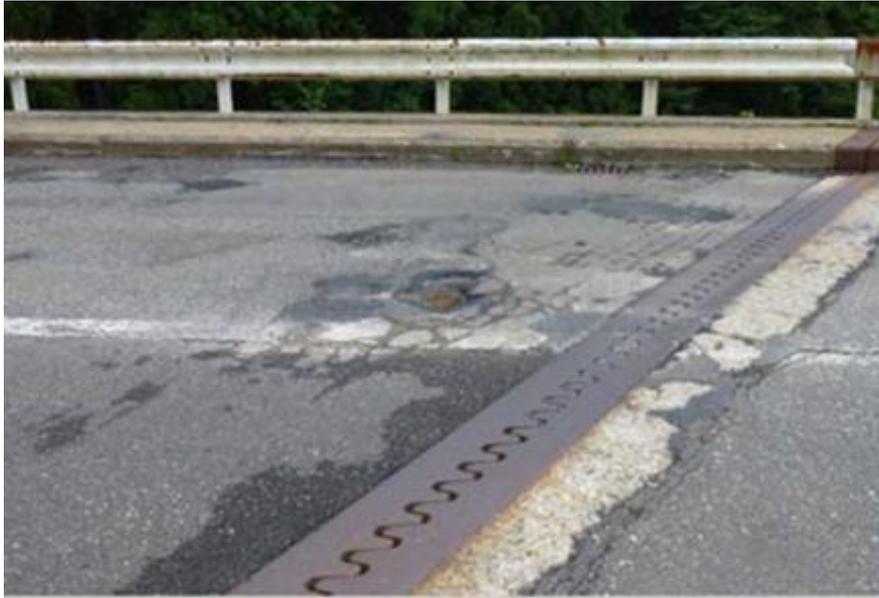
**Figure 3.3: Fatigue damage of reinforce concrete on highway bridge**

(b) The state near the joint of bridge

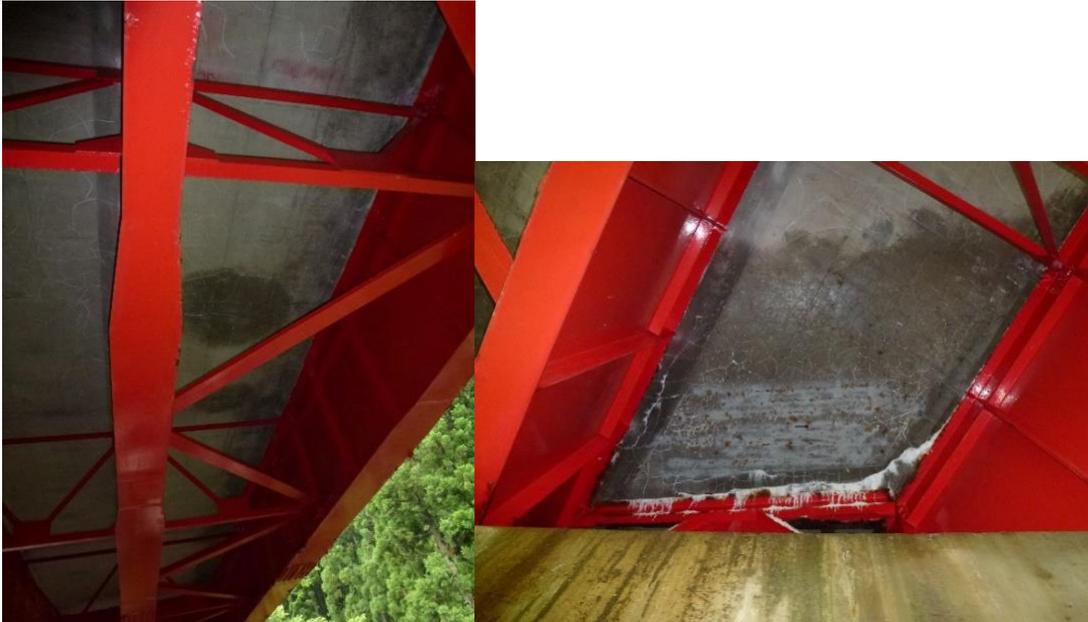
**Figure 3.5: The under surface of bridge**

(a) Loading point D2

(b) Loading point U0

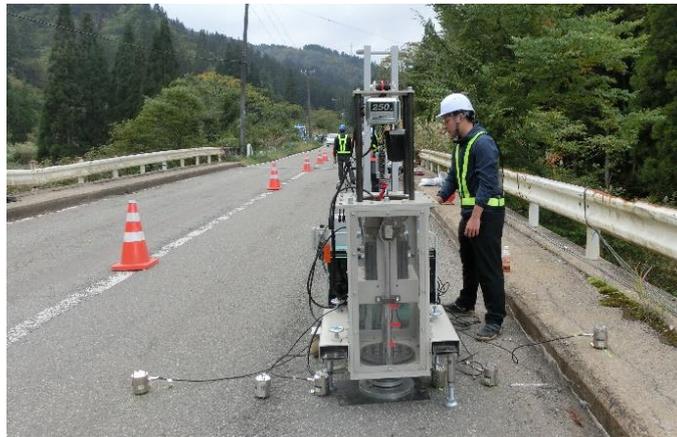
(a) SIVE

**Figure 3.6: SIVE, FWD light and Doppler system**

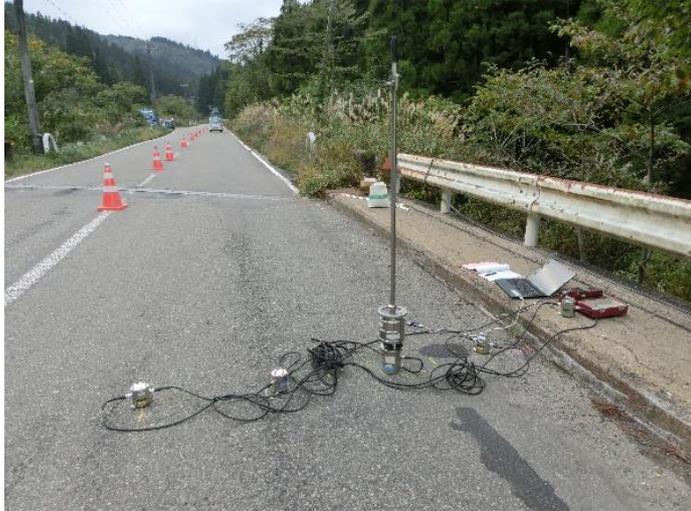
(b) FWD light

This time, we focused on each loading point of the bridge and organized the data. In addition, another displacement measure method was applied such as: FWD light (Figure 3.6(b)) using displacement gauges and Doppler system measure (Figure 3.6(c)) for more reference results.

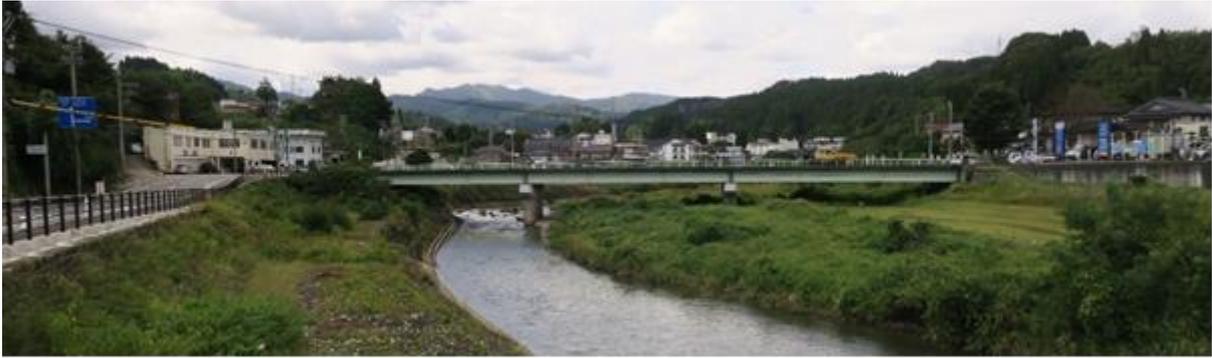
Yatsuo Bridge, as the target of this research, is a synthetic plate girder bridge with three spans and is located on a city road in Toyama Prefecture. The bridge has five main girders, and reinforced concrete is used for the deck slab (hereinafter referred to as RC). The length of the objective span is 29.20 m, and the total width is 14.80 m. At the time of the testing, a number of places showed discoloration from water exposure on the lower surface of the slabs during a visual inspection.

**Figure 3.18: Yatsuo Bridge**

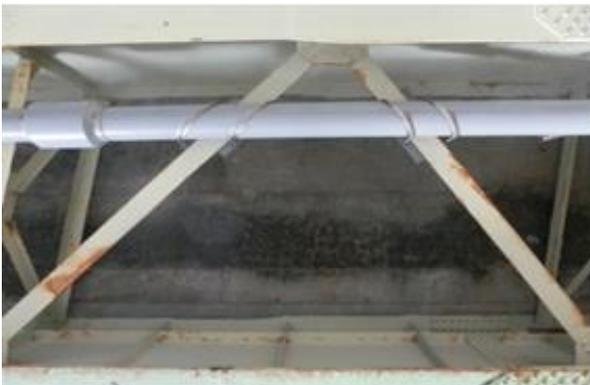
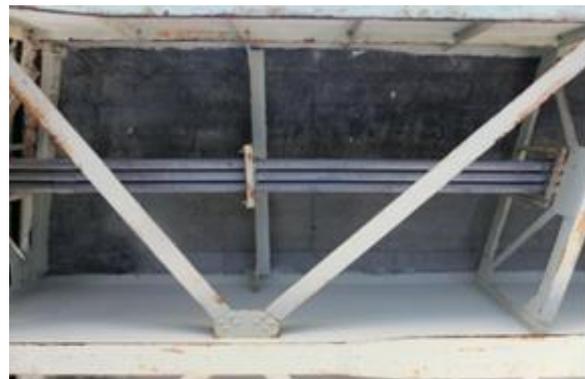
**Figure 3.19: Deterioration of bridge deck**

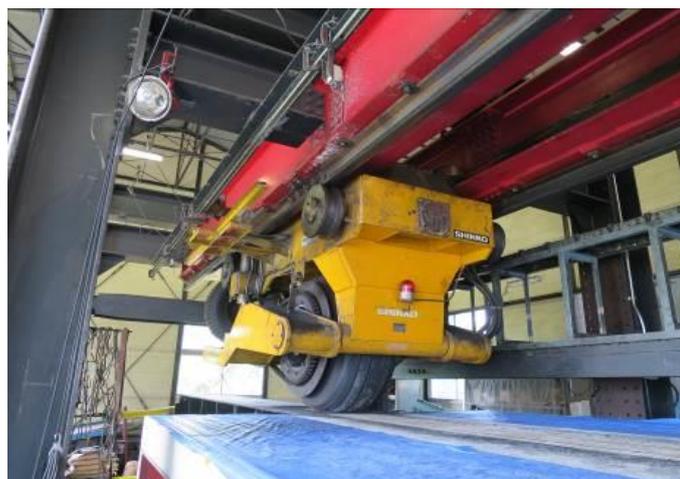
**Figure 5.3 Wheel load running test machine**

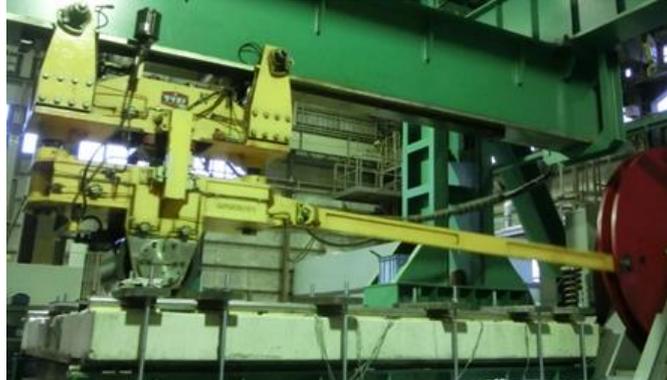
**Figure 5.4 Crank type running test machine**

The slab was fixed to the supporting girder with bolts in this test. After reinforcement with CFRP rods, the loading carried out by crank type running test machine (Figure 5.4), in this test, the slab was simply supported with round bar.

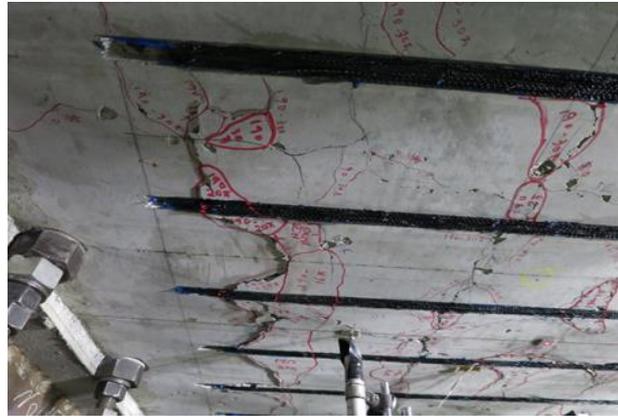
**Figure 5.7 The fixing end of carbon fiber after experiment**
