# The Serious ASR Problems in Hokuriku District, Japan, and Its Mitigation Effect by Using Fly Ash Concretes

Central Nippon Highway Engineering Nagoya Co. Ltd  
Technical Adviser & Professor Kazuyuki Torii

# Contents of Presentation

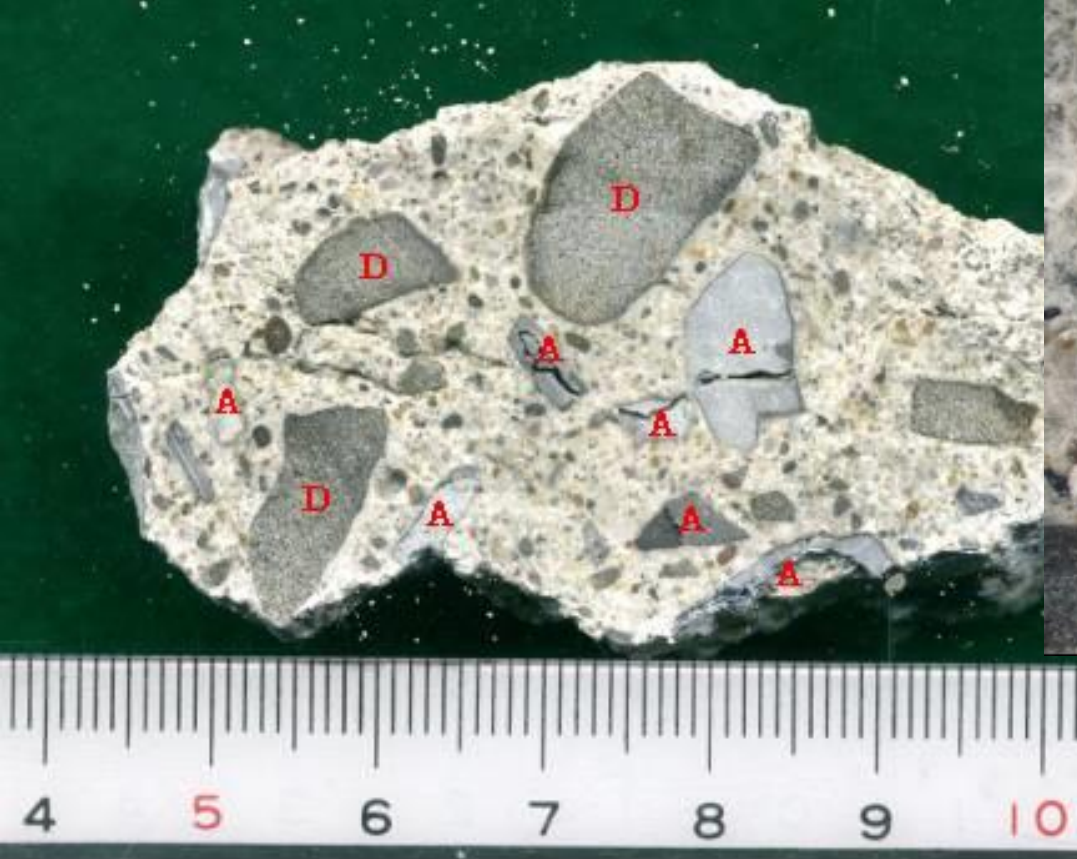
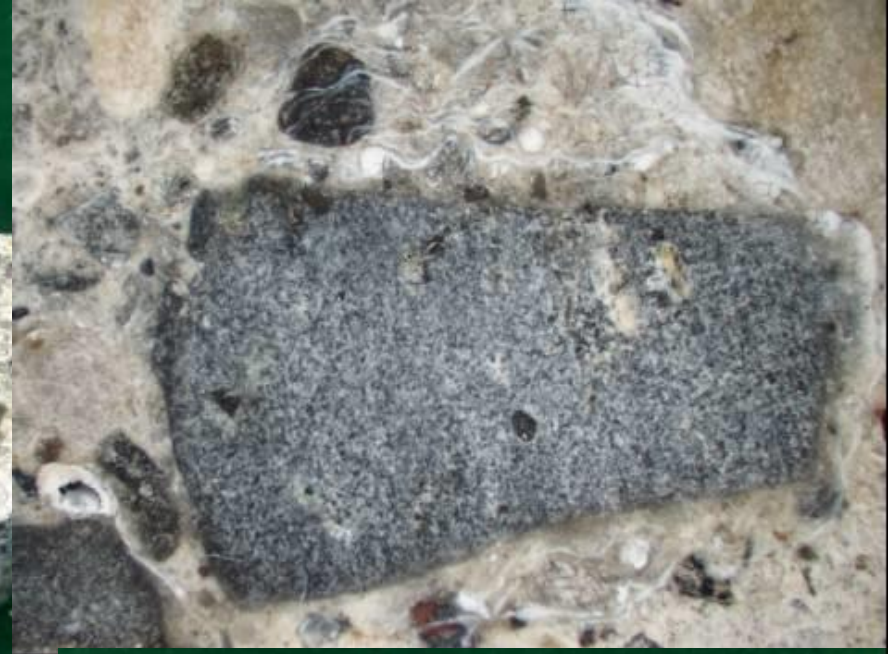
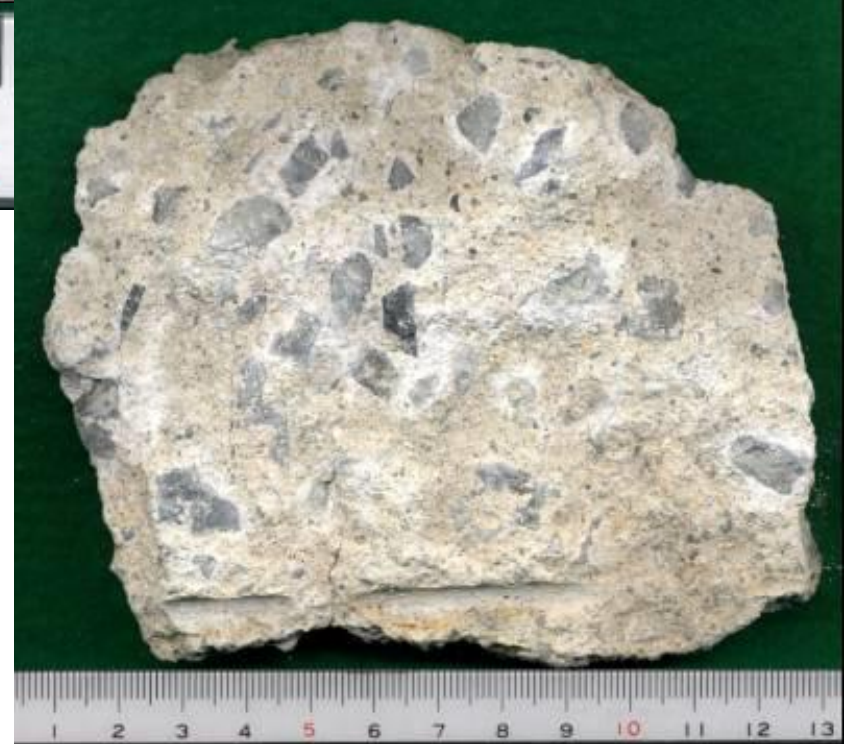
Fractured Surface of Concrete Samples in Tohoku District

A: Andesitic Stone (very reactive)  
D: Dacitic Stone (moderately reactive)  
in Tohoku District

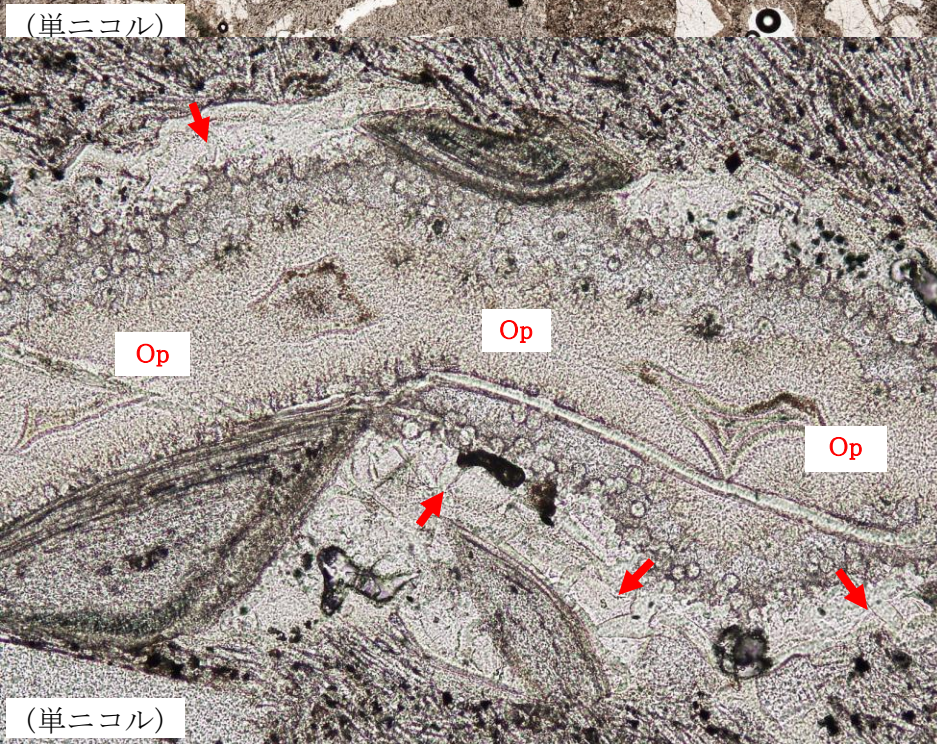
Thin section of core from PC slab-typed bridge girder of railway cracked in only few years after construction.

Polarizing microscope observation shows ASR gel from andesitic stones containing opal.

Op: opal, most reactive component

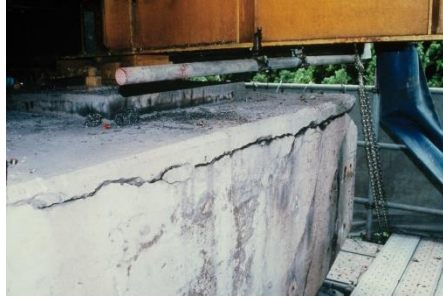
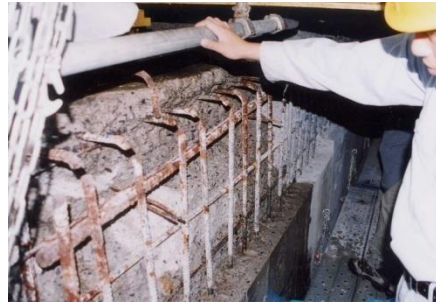
## 【ASR ( bridge pier ) 】

In the Hokuriku district, a large number of concrete structures have been suffering from ASR and chloride attack . The approach to solve these problems has been considering both **the repair of deteriorated structures** and **the use of preventive countermeasures**. In the former case, action has been taken by government office, but in the latter case, they have not yet taken any action.

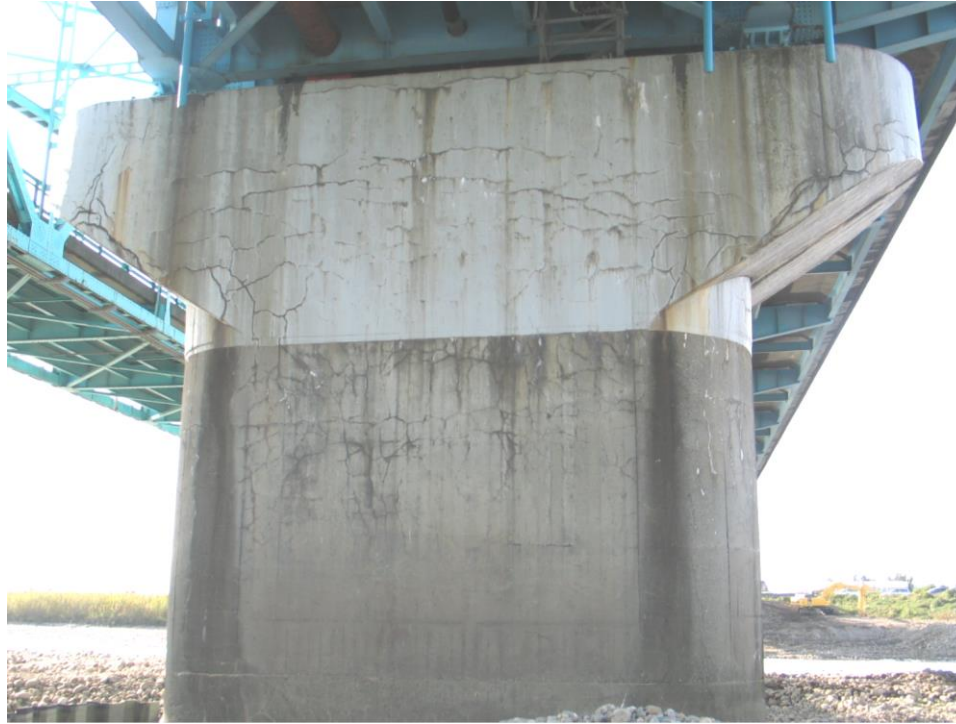
# The Reconstruction Case for Severely ASR-deteriorated Bridge Pier with Broken Rebars after Repairing in Toyama

Within the whole watersheds of the Joganji and Jinzu Rivers in Toyama Prefecture, all aggregates possess a very high ASR reactivity, and in some cases a **pessimumn content effect**, because all these aggregates contain andesite particles with opal and/or cristobalite as a reactive component.

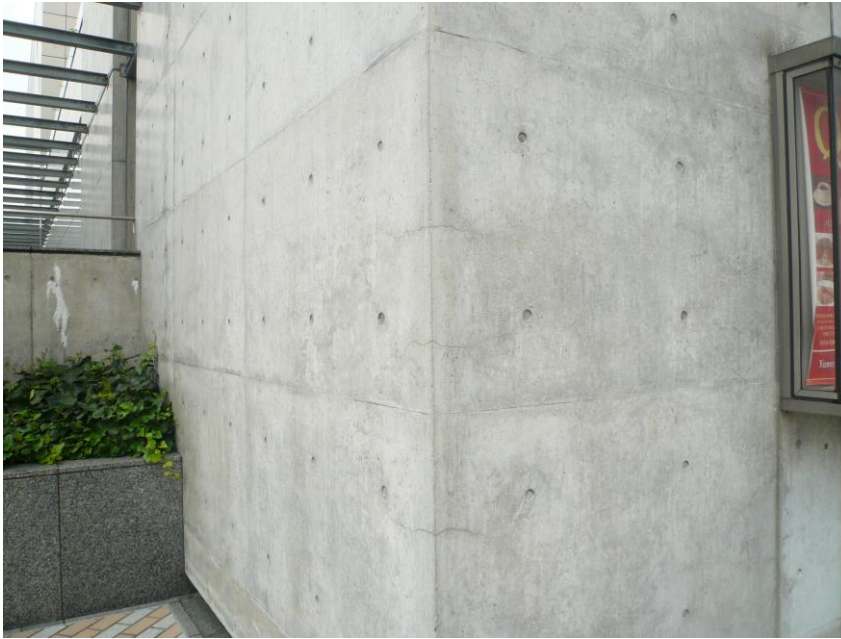
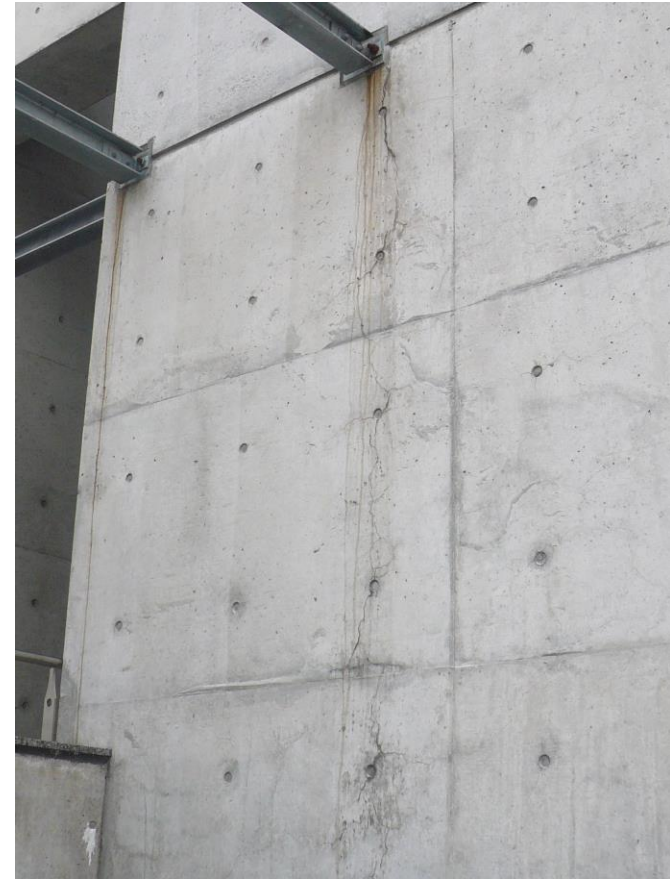
# The Recent Case of ASR Cracking Occurred in RC Building Wall after JIS A5308 Regulation in Toyama

The fine and coarse aggregates from the Jinzu River have been assessed as “**innocuous**” and the total alkali content of the concrete has been kept below  $3\text{kg/m}^3$ , **presumably around  $2.4\text{kg/m}^3$** . Nevertheless, the severe ASR recently occurs. **Why does ASR occur and still continue ?**

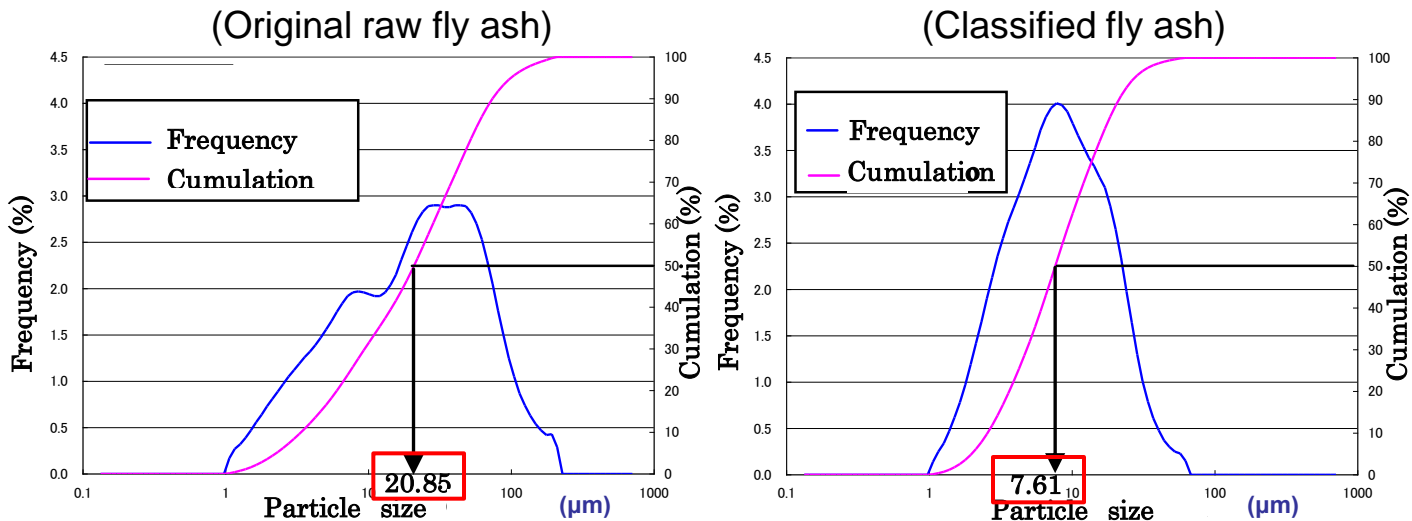
Comparison of particle size and frequency between original and classified fly ash

**The physical properties of fly ash can be improved from 21μm to 8μm at the average particle size by classification.**

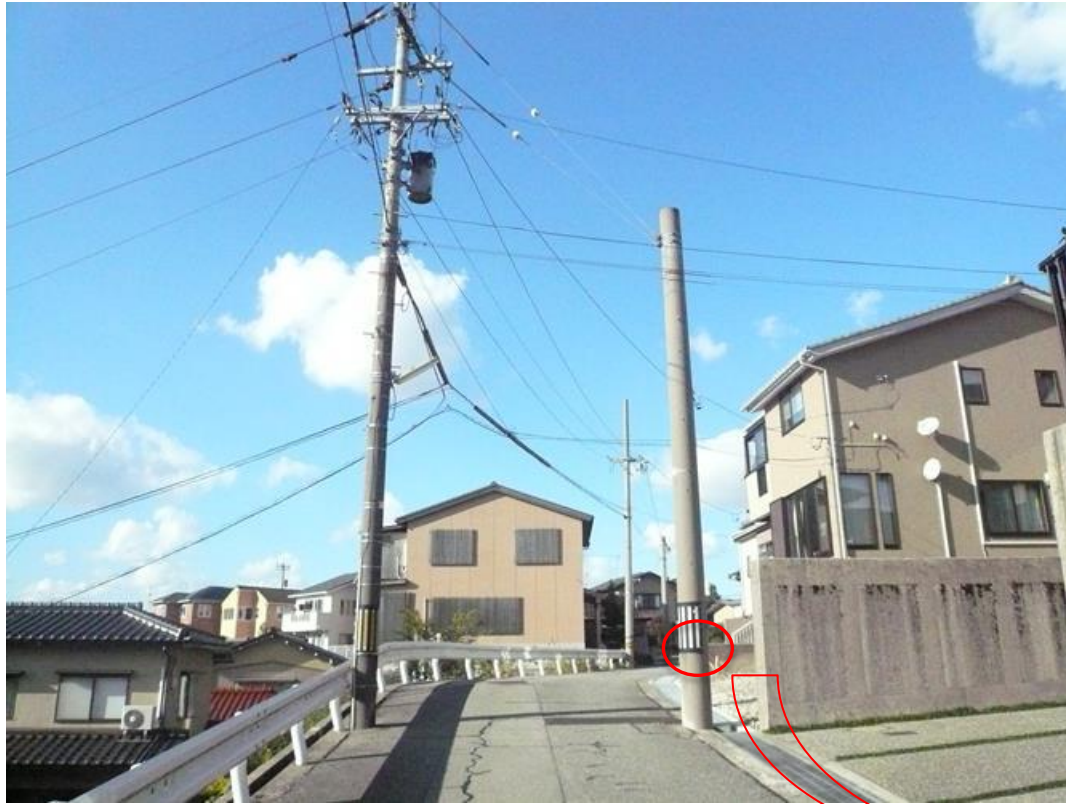
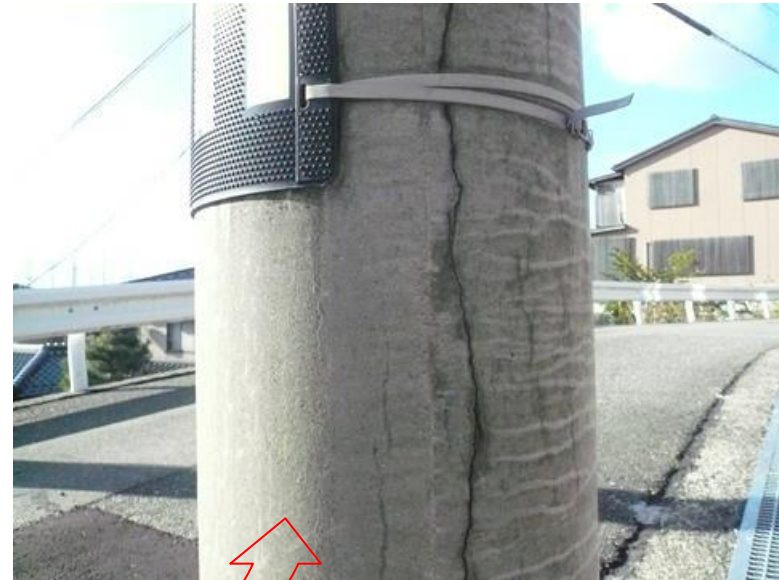
- Recently in the Hokuriku district, it has been found that large vertical cracks occurred on the surfaces of the electrical concrete poles. However, the cause of the cracks has not been clarified.

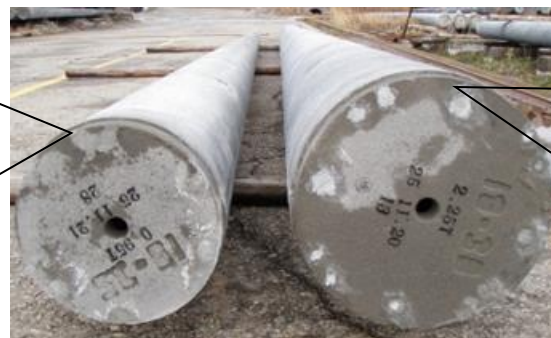
# 【Structure of the Pole】

**Designed strength of special type poles has a higher strength of 50 N/mm<sup>2</sup>.  
In many cases, severe cracks occur in this special type poles.**

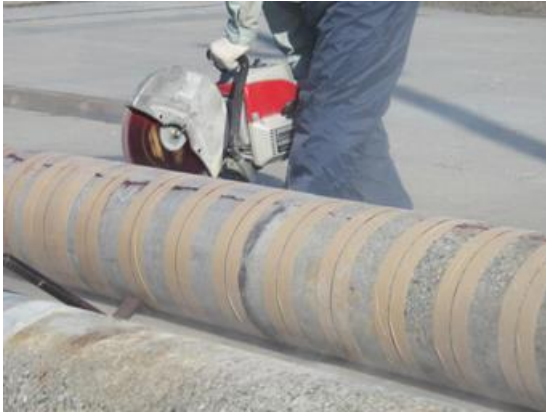
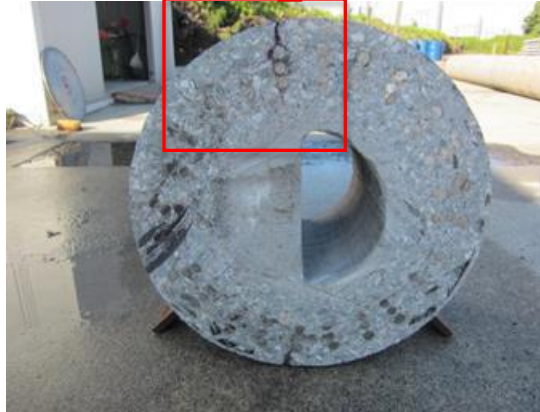
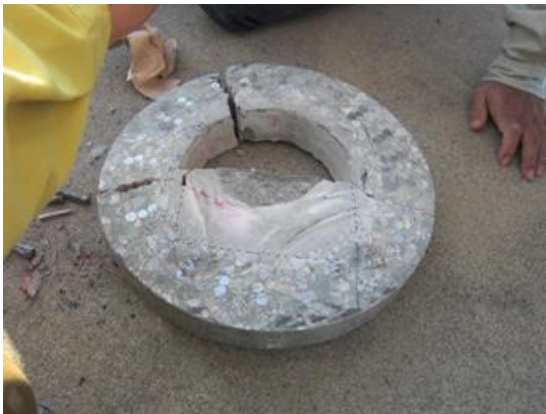
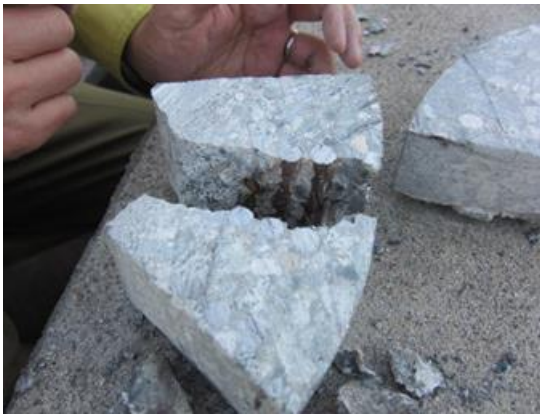
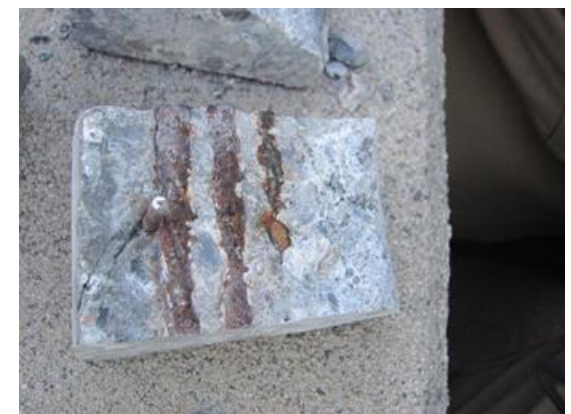
# 【Research of the Poles】

**Sliced the poles at 10cm intervals and checked the situation inside the cracks.  
And then, taken out concrete pieces to investigate the cause of the cracks.**

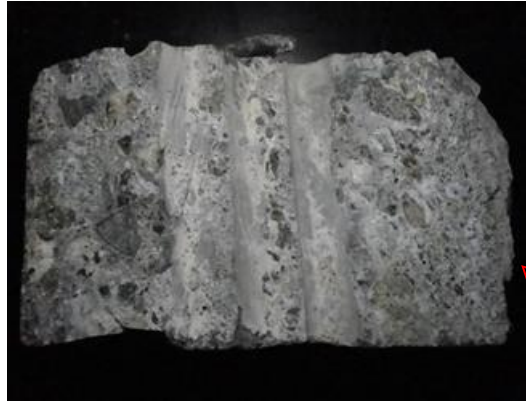
# 【Observation of ASR gel (Gel Fluorescence Test)\*】

The area where ASR is present shows a characteristic greenish yellow fluorescence.

**The fine aggregates of some volcanic rocks were intensely generating ASR especially in the interior of PC pole columns in the hollow cross sections.**
